THERMO-MECHANICAL CHARACTERIZATION OF
SILICON CARBIDE-SILICON CARBIDE COMPOSITES
AT ELEVATED TEMPERATURES USING A UNIQUE
COMBUSTION FACILITY

DISSERTATION

AFIT/DS/ENY/09-S01

AIR FORCE INSTITUTE OF TECHNOLOGY

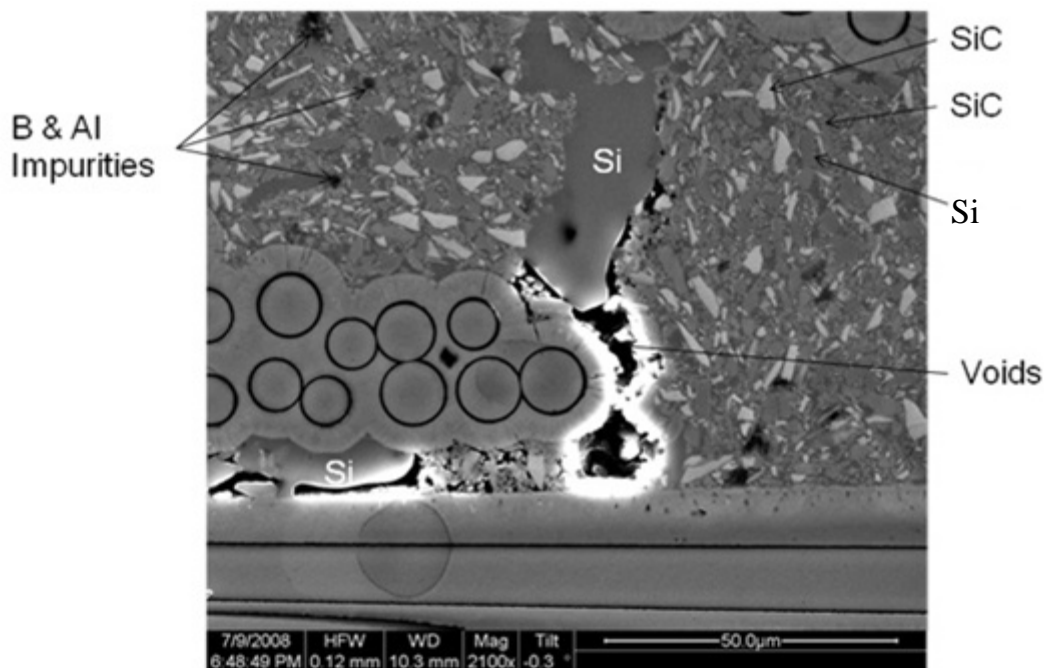
Figure 113: Chemical composition of the MI woven Syl-iBN/BN/SiC

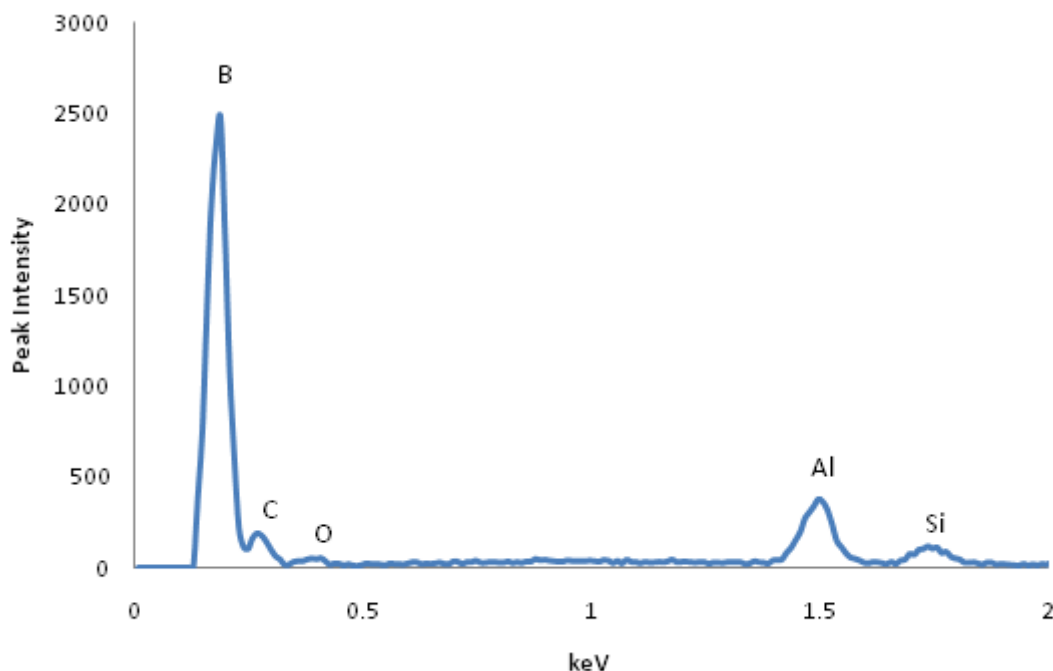
Figure 114: Chemical species in the dark spots in the MI matrix of the woven Syl-*i*BN/BN/SiC detected using EDS

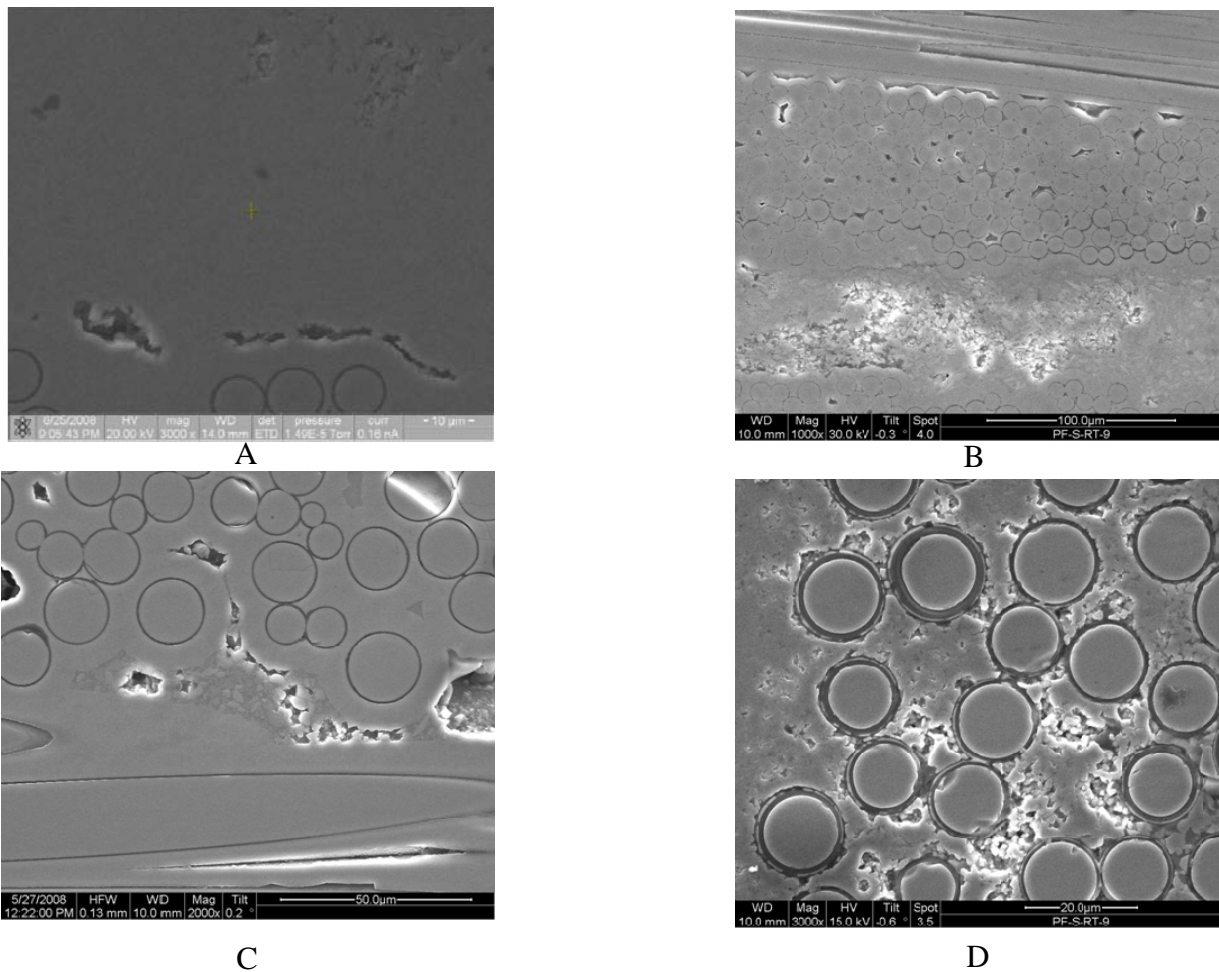
Figure 115: Matrix recession in all four CMCs: (A) woven MI Syl-iBN/BN/SiC, (B) woven MI Syl/BN/SiC, (C) woven MI Hi-Nic-S/BN/SiC and (D) prepreg MI Hi-Nic-S/BN/SiC

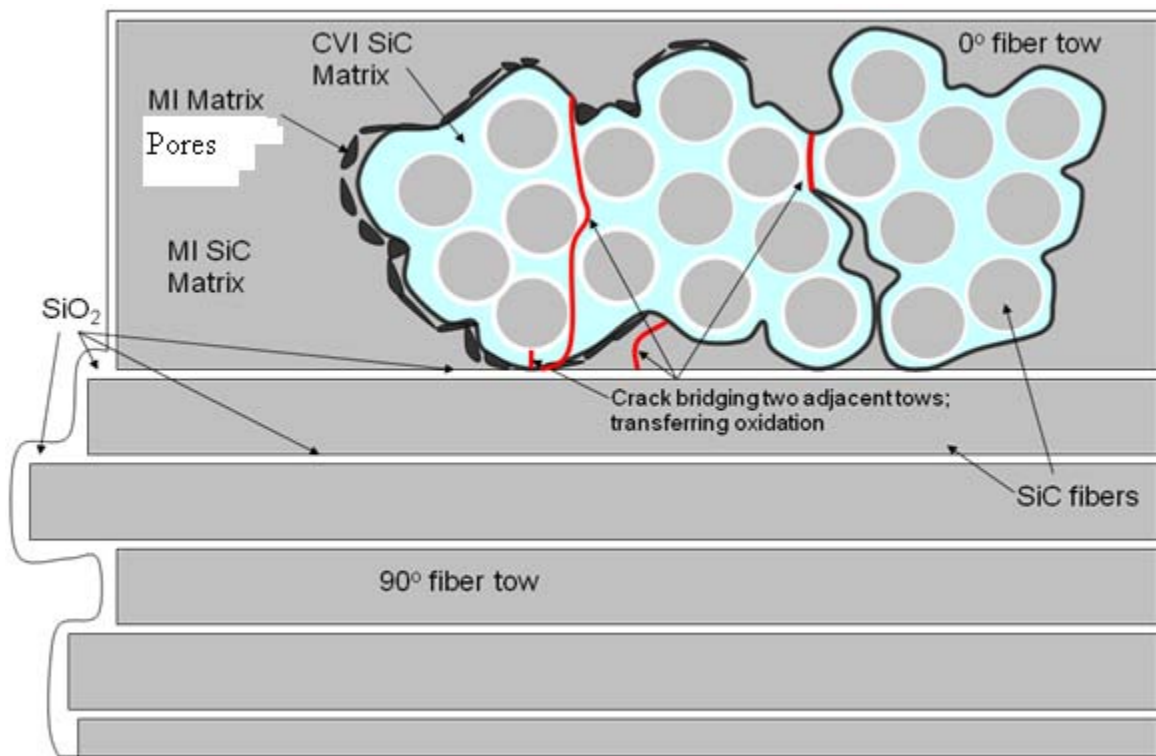
Figure 120: Illustration of how the load carrying fibers (whose cross-section is shown) in the bulk interior are reached in by the oxidants of the environment

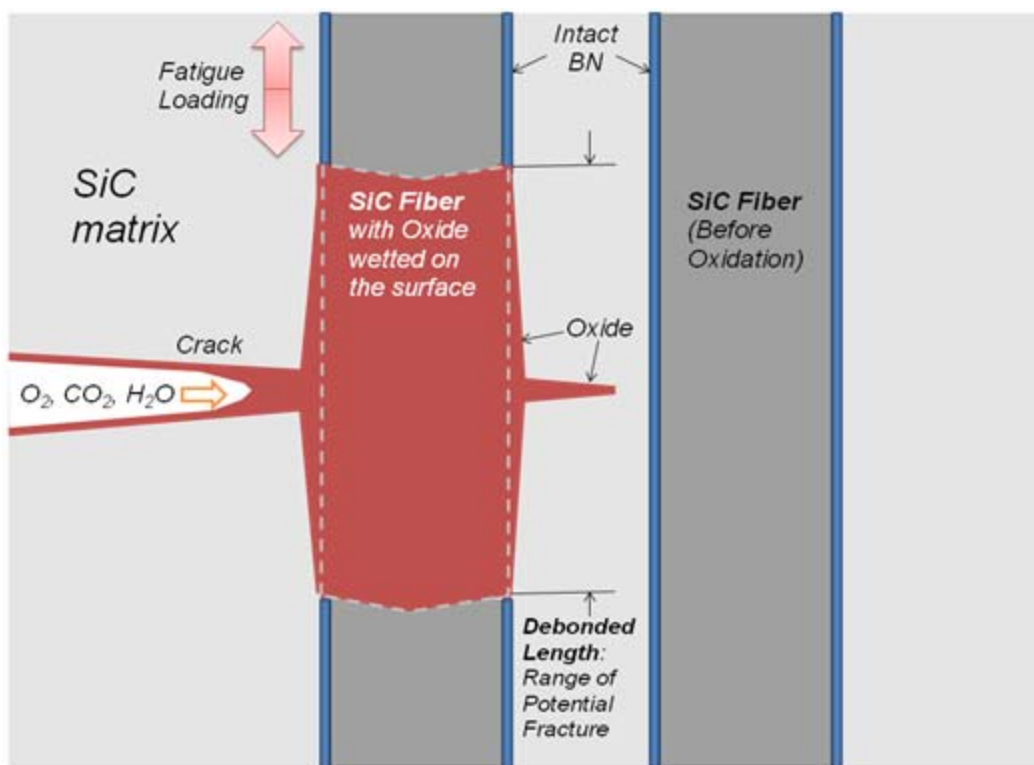
Figure 121: Schematic illustrating the crack growth followed by the oxidation of BN interphase

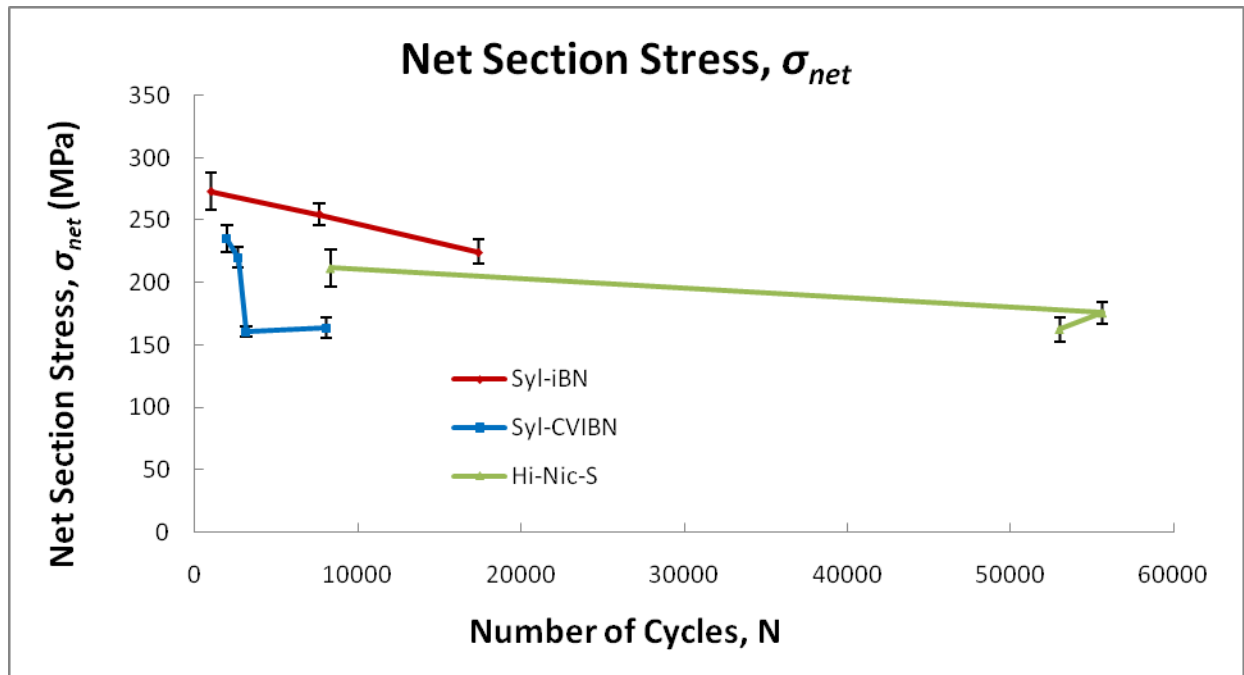
Figure 124: Net Section Stress vs. number of cycles for three woven MI CMCs

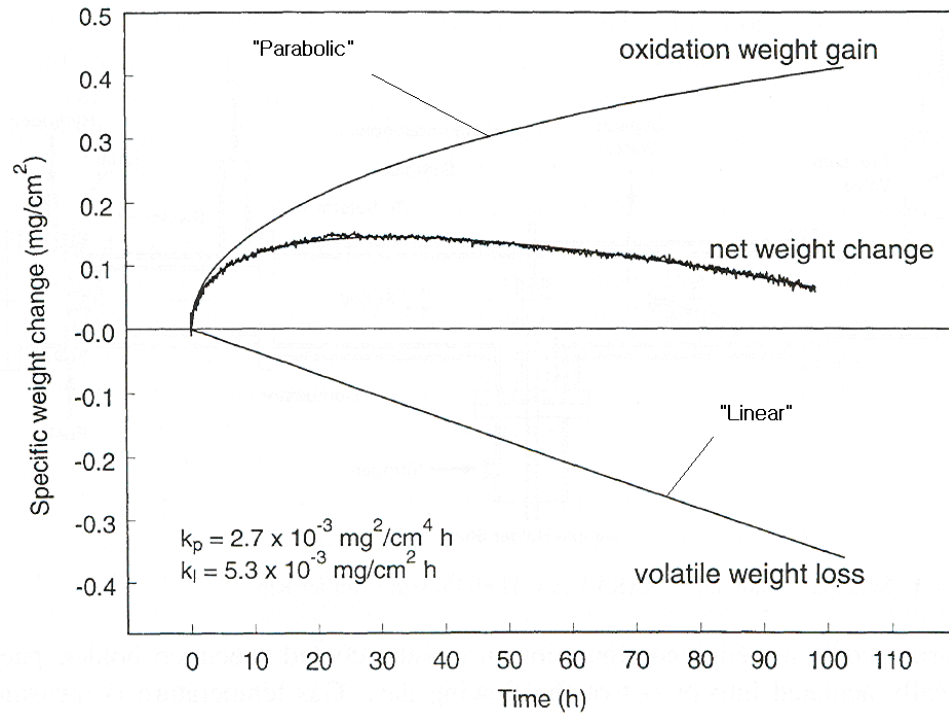
Figure 126: Parabolic weight change curves for CVD SiC [84]

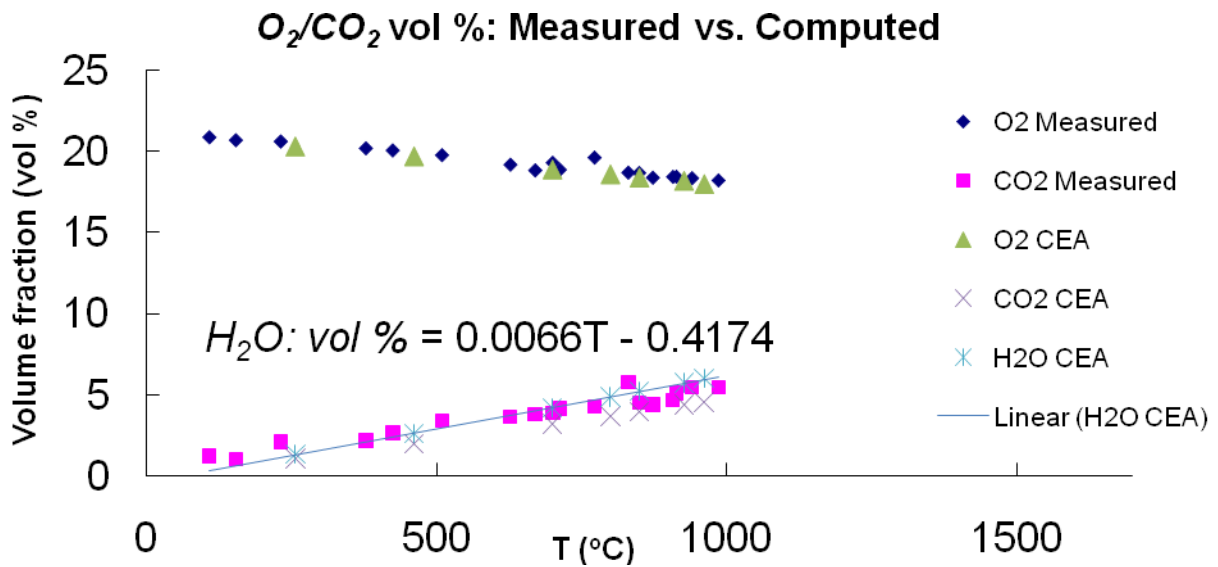
Figure 132: CO_2 and O_2 concentrations in the flame with temperature
